FINAL REPORT ON I470 WHEELING BRIDGE

HANGER CABLES AND CRACKS

IN TIE GIRDER DIAPHRAGMS

Fritz Engineering Laboratory Report No. 491-1(84)

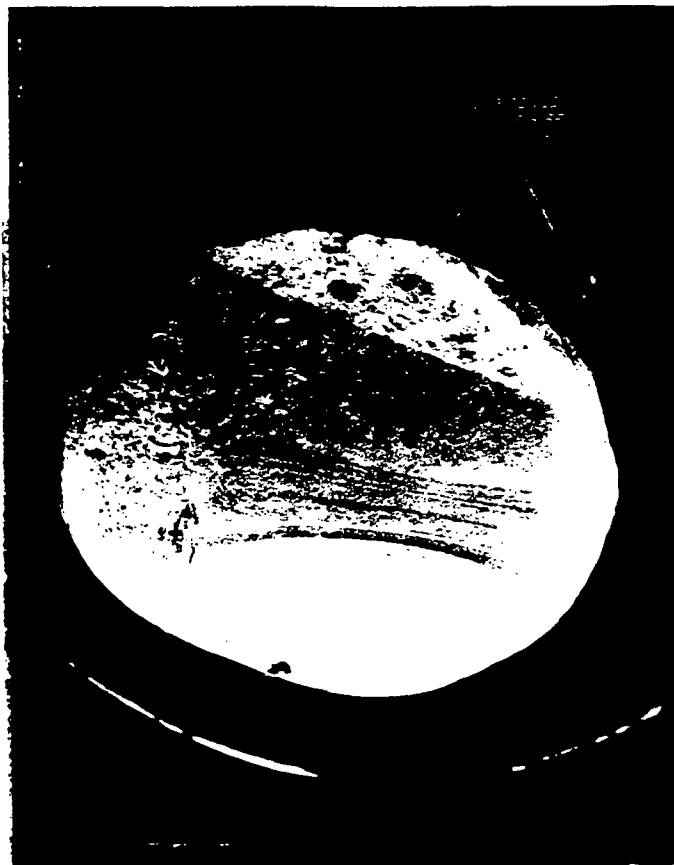
It is now evident that failure of this wire was by a fatigue mechanism, as may be seen from the "beach marks" on the crack surface. The initiation point on the wire is at the right-hand side of Fig. 10, which corresponds to a rub or gouge mark. The final fracture was the steep

slant fracture region on the left. The overall load on the wire was not high, as fatigue cracking progressed through at least 50% of the wire cross-section before fracture occurred.

Fig. 10 Wire I-1 SEM Micrograph of
Fracture Surface (cleaned), 20X

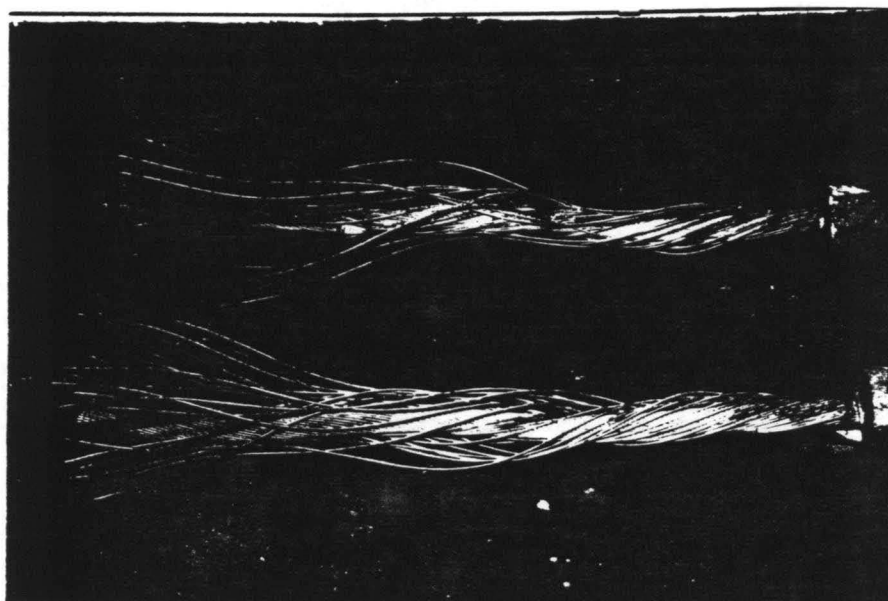
Fig. 22 Specimens D and E After Failure

All three of the specimens failed at the swaged fitting, as can be seen in Fig. 22. None of the wires broke at the original button sockets.

Table 3 provides a summary of the test results. Specimen A with no broken wires and not fatigue tested provided about the same capacity as Specimen E with no broken wires but subjected to 4 million stress cycles. The maximum load was 573 kips for Specimen A and 578.5 kips for Specimen E. Specimen D with three broken wires failed at 520.5 kips.

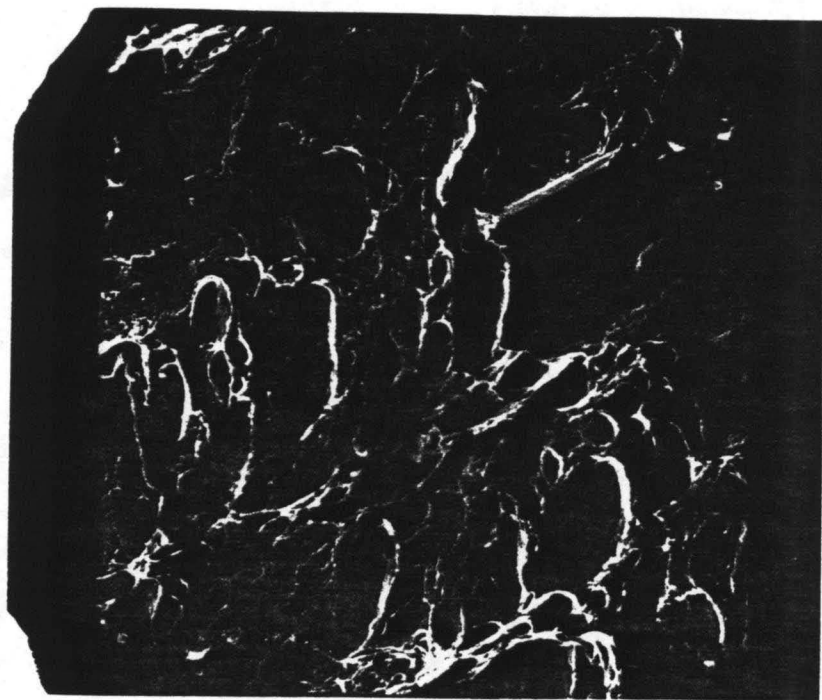
The fracture surface area of several samples were examined for evidence of the nature of the fracture process involved. The results of these studies are seen in Figs. 32 to 39. Scanning electron micrographs of portions of sample 4'S (see Figs. 32 to 34) showed evidence of fatigue crack growth and ductile tearing. The evidence of fatigue crack growth is most clear in Figs. 32 and 33, with broad striations clearly shown in Fig. 32, and striations mixed with ductile tearing seen in Fig. 33. Figure 34 shows evidence of ductile tearing. The mixed nature of the fracture surface suggests that crack growth proceeded at very high levels of stress range (high stress intensity range, ΔK). Both the broad striations and dimple rupture are characteristics of high stress range fatigue. Scanning electron micrographs from sample 6N also showed ductile tearing, as seen in Fig. 35.

Fig. 33 SEM Micrograph of Sample 4'S, 600X

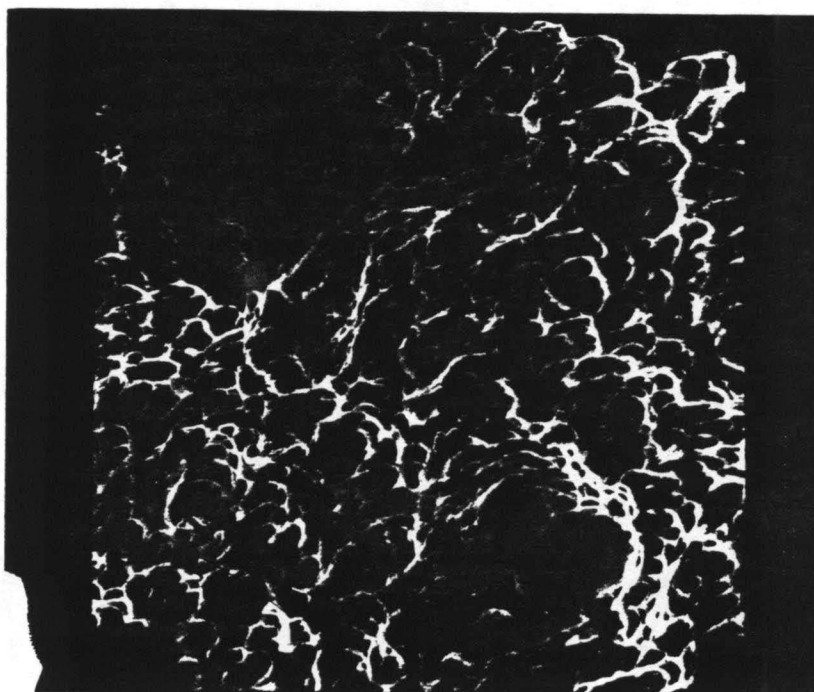
Fig. 34 SEM Micrograph of Sample 4'S, 1400X

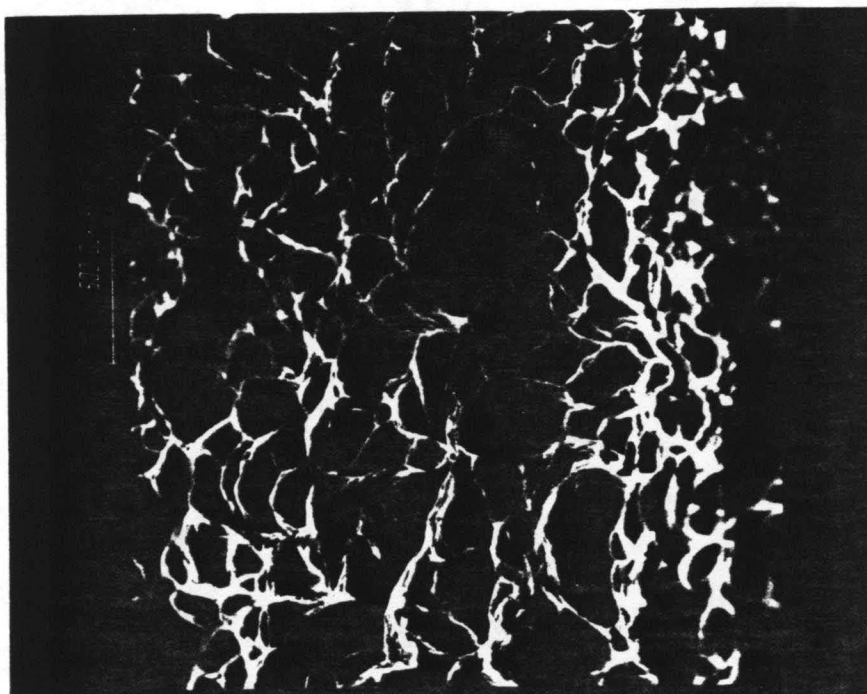
Fig. 35 SEM Micrograph of Sample 6N, 2500X

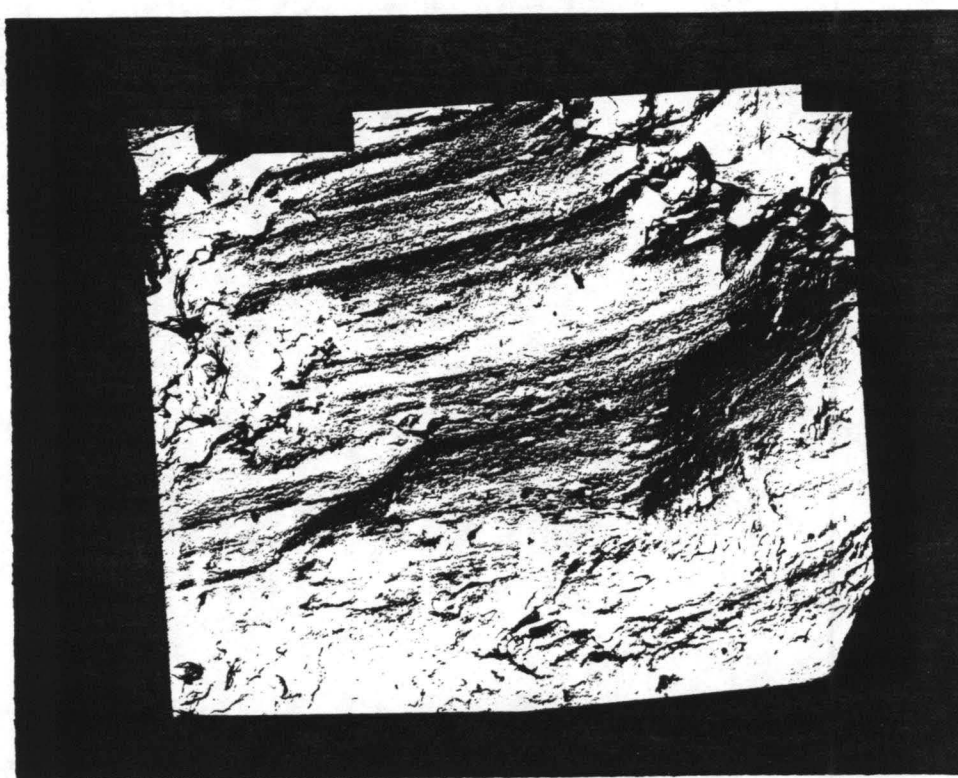
Transmission electron micrographs were prepared from replicas taken from sample 3'S. Here the fatigue striations are clearly seen in Fig. 36 and 37, and dimple rupture can be seen in Figs. 38 and 39. Once again this suggests that the fatigue crack growth developed at high ΔK levels. From the striation spacing in Figs. 36 and 37, it appears that the crack growth rates are between 0.6 and 1.4×10^{-5} in/cycle for this sample.

Fig. 36 TEM Micrograph of Sample 3'S, 5000X

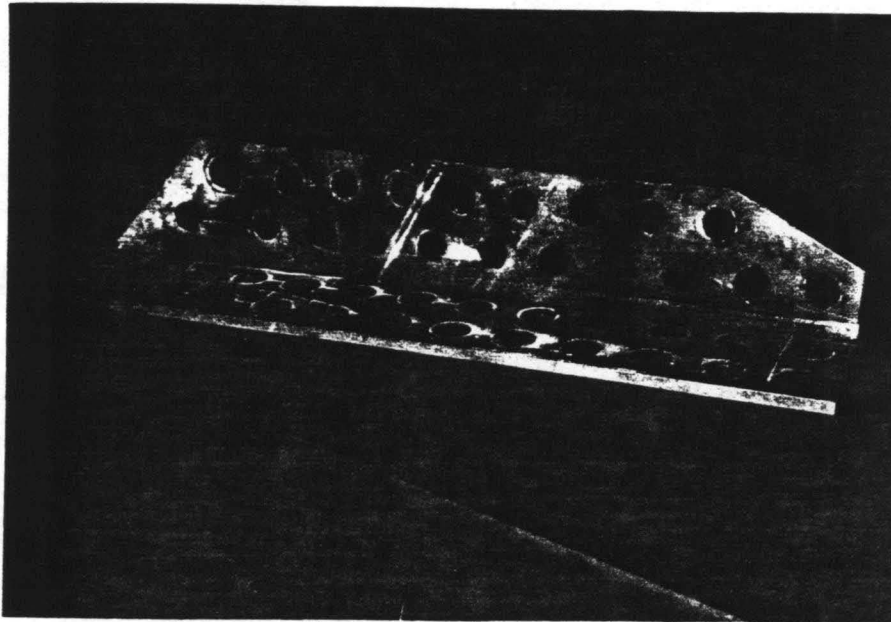
Fig. 66 Overall View of Cracked Hanger Support

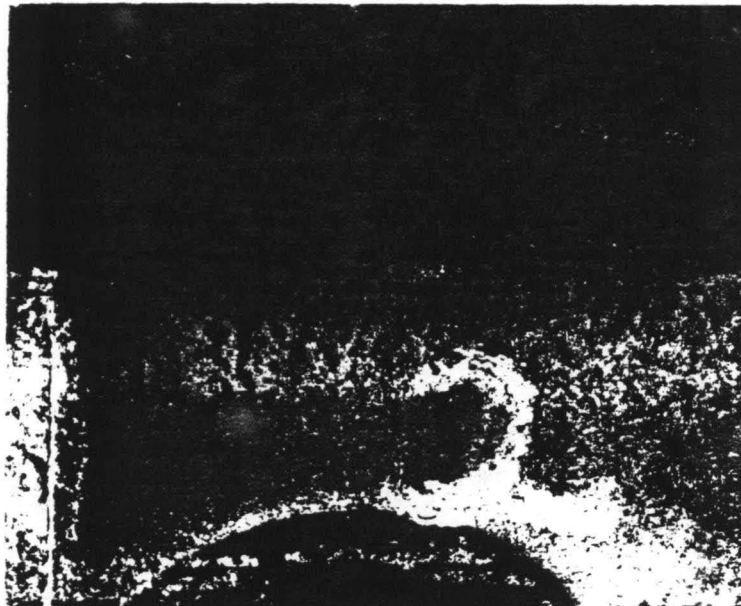
(b) Paint Extending Beyond Weld Toe Onto Crack Surface

Fig. 74 Sawed Section Showing Exposed Crack Surfaces

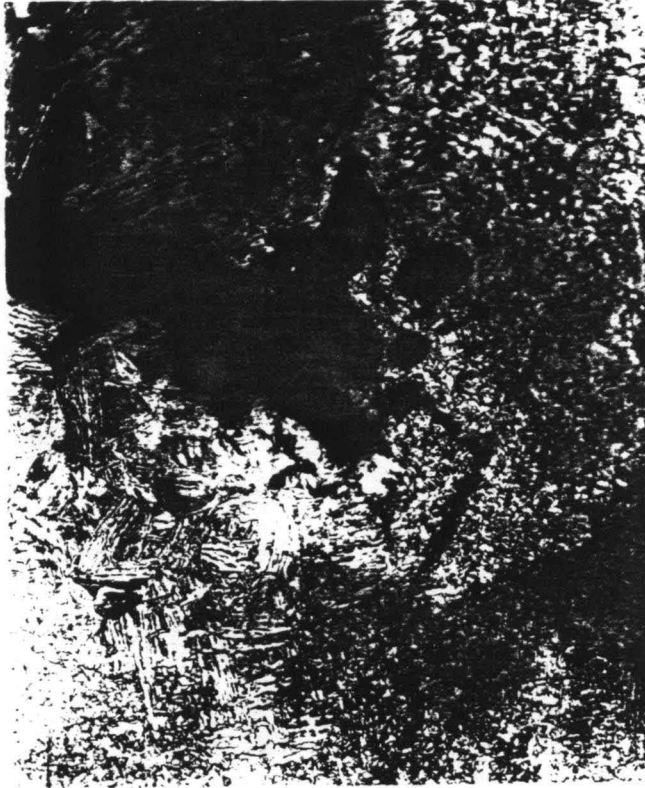
Fig. 75 Crack Tip with Fatigue Extension, Sample 2 (100X)
